GOOD OLD BOAT™

Issue 101 March/April 2015

AN ENGINE WITH A FEVER

The diagnosis was elusive and surprising

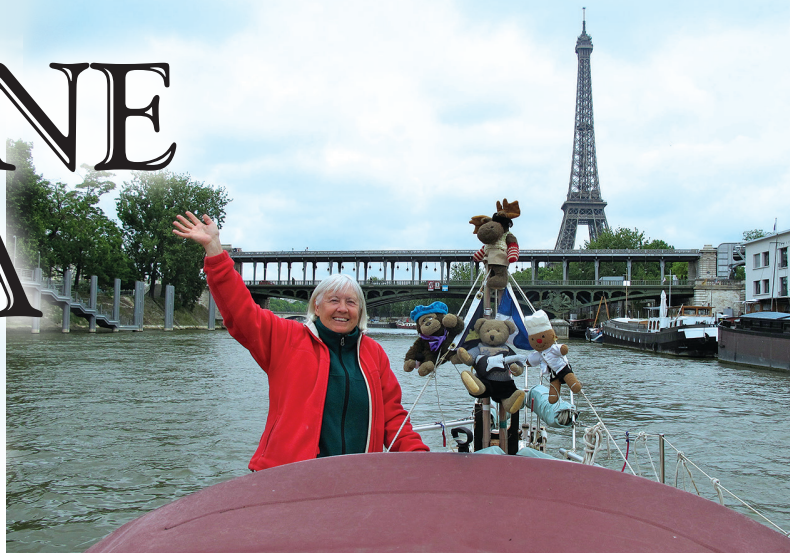
Ellen expresses glee and relief at *Entr'acte's* arrival in Paris, at top. On the way, the engine had overheated frequently due to a damaged impeller in the raw-water pump, above. The center hub, which held the pin that engaged the drive shaft, broke loose — but gradually.

only passes through a center hub that is somehow bonded to the outer body. It was this bond that had broken loose.

In the aftermath of the impeller failure, I resolved to find replacements of the “old style” where the pin passes completely through the impeller. This, after great effort, I accomplished, but apparently to no avail. Even this seeming foolproof design is prone to exactly the same sort of failure. Over a period of six months I saw three such failures and they were of both designs. The moral is to change your impeller often and carry spares. They just don’t make them like they used to.

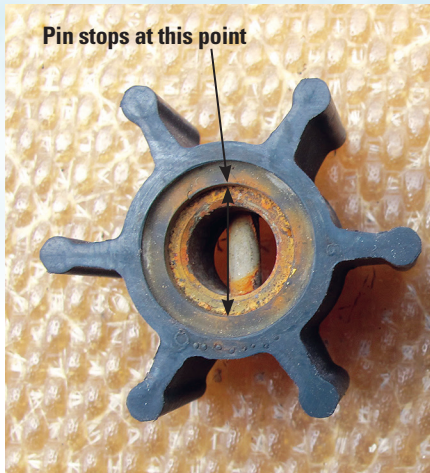
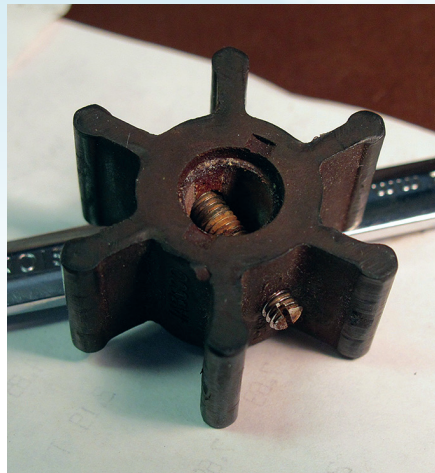
In the new style of water-pump impeller, far left, the retaining pin does not extend past the metal hub. In the old design, near left, the pin passes completely through the body of the impeller to hold it captive.

Our new batch of impellers differed substantially from the former design. In the old design, the drive pin passed all the way through the body of the impeller, much like the shear pin on an outboard motor’s propeller. The new design has a much shorter drive pin that

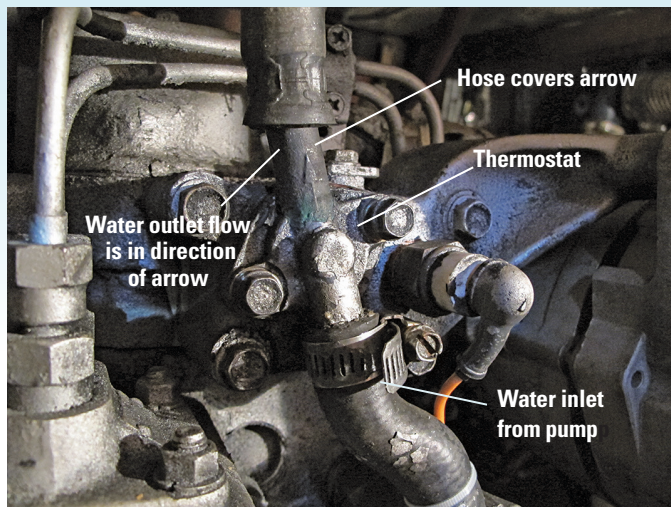
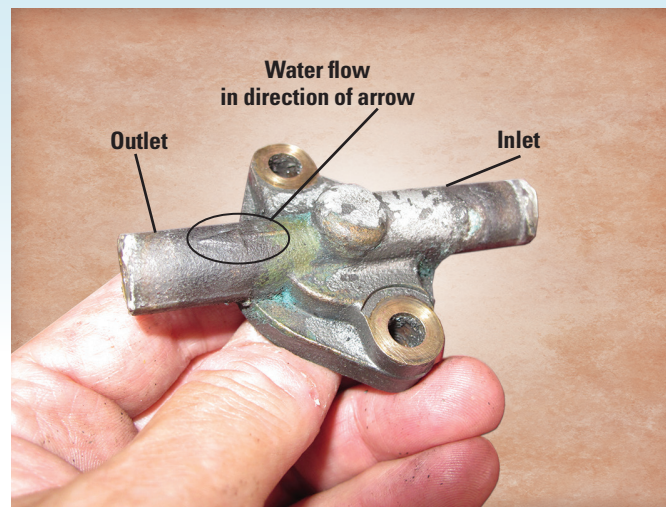
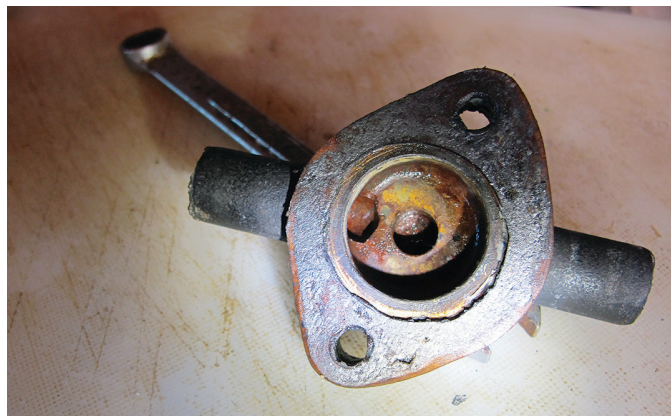
An arrow on the thermostat housing indicates the direction in which water should flow, but this arrow is covered when the hose is installed, above left. The thermostat housing is symmetrical in appearance, above, and will fit the wrong way just as easily as the right way. Inside the housing it's a different story, at left. The inlet and outlet clearly must not be reversed.

After breakfast I dove into the engine room, praying for all I was worth. I removed both hoses from the thermostat cover and looked closely at the cover itself. Yes, yes, *yes!* Sure enough, embossed quite clearly on the cover

arrow pointing up. I had mounted it upside down.

The thermostat cover has two ports, an inlet and an outlet. Viewed from the outside, the hose barbs appear identical. Inside the cover, however, the orifices are not only of a different size, but each is oriented differently to the flow of water. The water is supposed to flow through the open thermostat into the engine. With the cover inverted, the water pump was pumping seawater into the outlet and directly onto the top of the thermostat, rather than through it. This restricted water flow into and through the engine. Some water could flow, but only enough to cool the engine at low rpm for a short time. The temperature would gradually rise and finally set off the alarm, especially if we raised the rpm for any reason. As far as the engine was concerned, the thermostat was constantly closed.

been under quite a bit of stress and inadvertently installed the cover upside down. The cover can be installed easily in either orientation, hence the arrow. But in the heat of battle, that arrow is very easy to miss, especially when it's completely covered by the hoses.
